Mackenzie District Council  
PO Box 52  
Fairlie 7949  
New Zealand

12 January 2021

### **Twizel Youth Centre Condition Assessment**

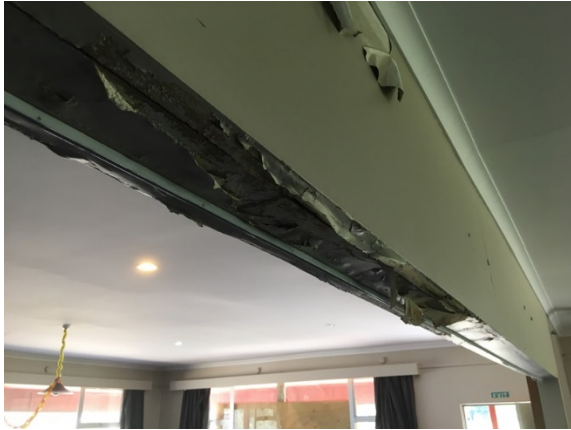
When viewed from the ground the roof appears to be in good condition. However, the verandah beams are rotting (photos 2 & 3) and the lintel dividing the Lounge and Kitchen/Dining areas appears to be wet (photo 1). It is possible that internal gutters are contributing to both issues.

Photo 1. Beam between Living and Kitchen/Dining

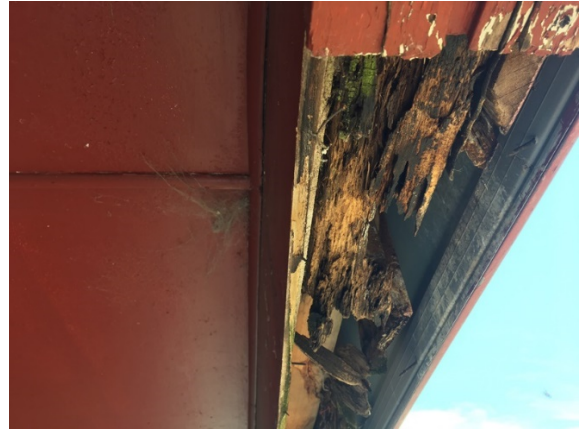
Generally, exposed timber verandah beams are rotting and the verandah posts are starting to show signs of decay (photos 2, 3 & 4). The subfloor space appeared to be dry and well ventilated (photo 5). The interior building framing was not visible without invasive inspection.

Photo 2. Verandah beam

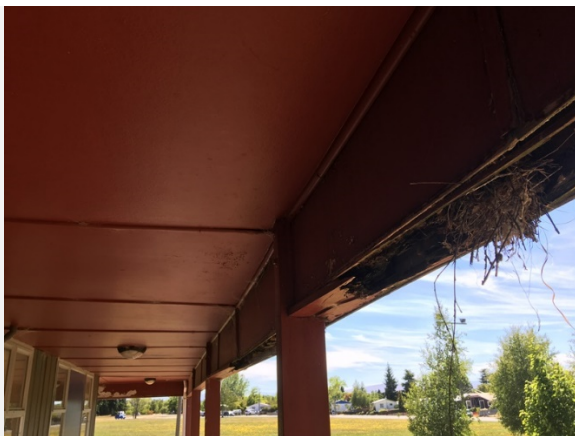
Photo 3. Verandah beam

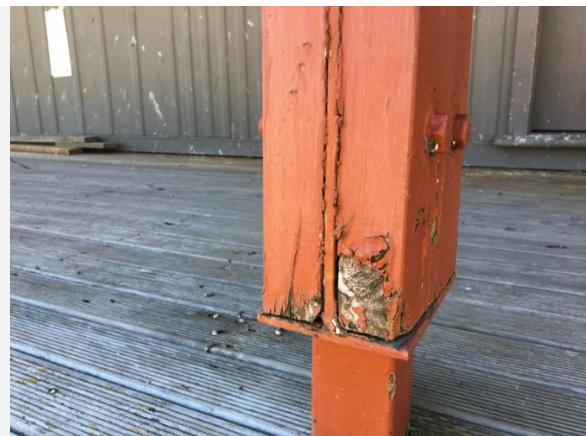
Photo 4. Verandah post base

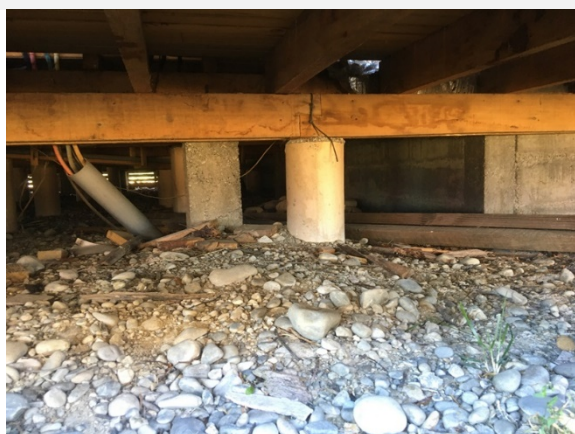
Photo 5. Subfloor

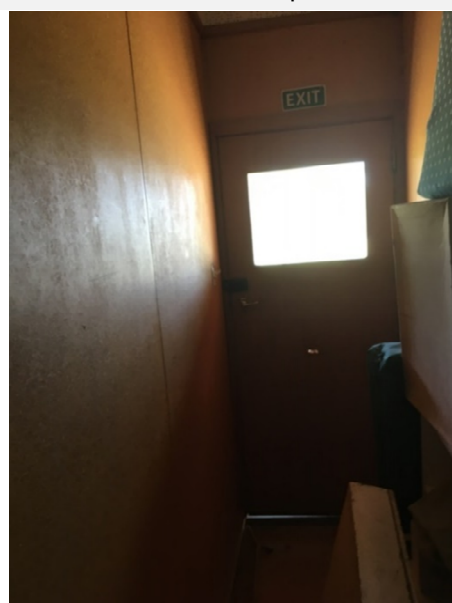
The egress route from the WC/Shower area to the building exterior is cluttered with storage items (photo 6).

Photo 6. Egress route

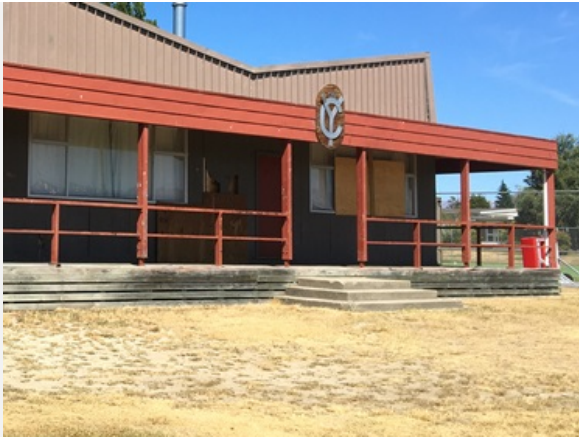
There are broken windows and holes in the fibre cement sheet cladding which will be impacting the buildings ability to remain watertight and secure (photos 7, 9 & 10).

There is no accessible parking nearby, accessible route into the building (photo 7), accessible route through the building or accessible features within the building. The pine decking is lifting and presents trip hazards in several locations.

Photo 7. Main entrance stair without handrails

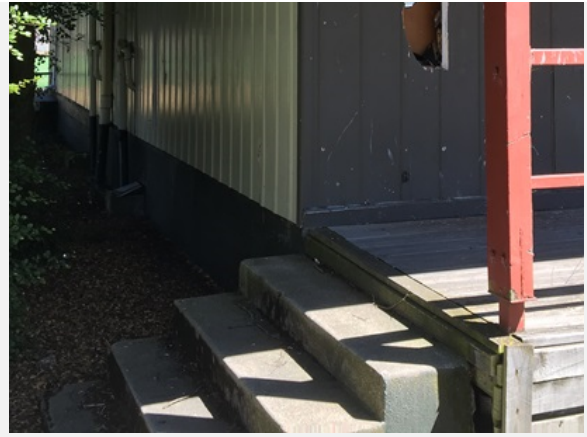
Photo 8. Secondary stairs without handrails

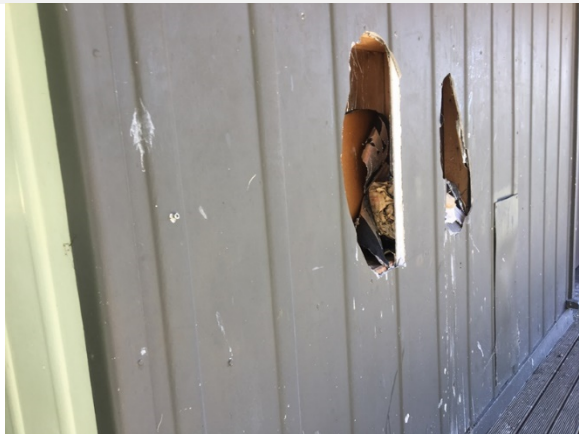
Damage to the exterior cladding indicates there is no thermal wall insulation (photo 9).

Photo 9. Cladding

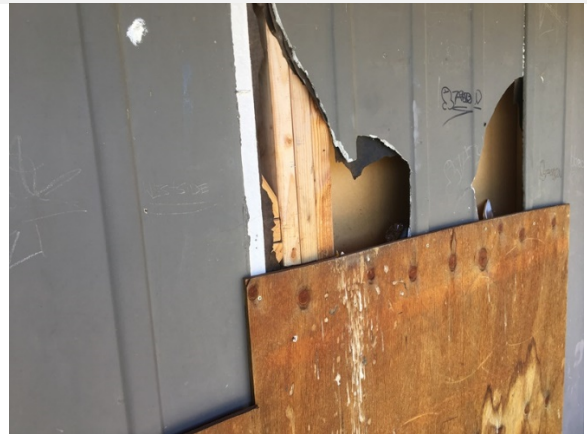
Photo 10. Cladding

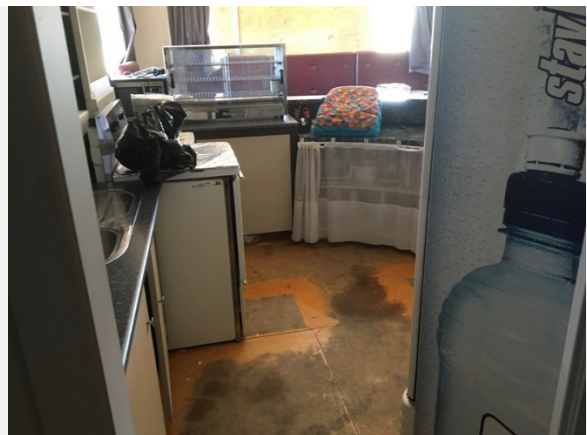
The floor surfaces of the Showers, WCs and Kitchen are not impervious or easy to clean (photos 12 & 13).

Photo 12. Kitchen floor

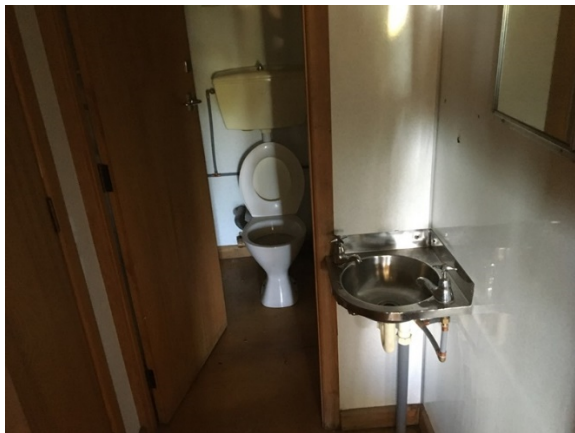
Photo 13. WC floor

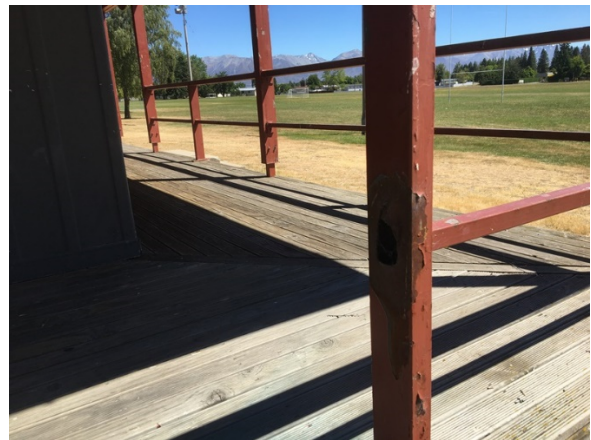
The deck balustrade is not a compliance requirement as the surface of the deck is less than 1 meter above the surrounding ground level. However, the balustrade should not be relied upon for physical support as several of the steel baluster posts are not connected to the deck and corrosion is evident (photo 14).

Photo 14. Balustrade

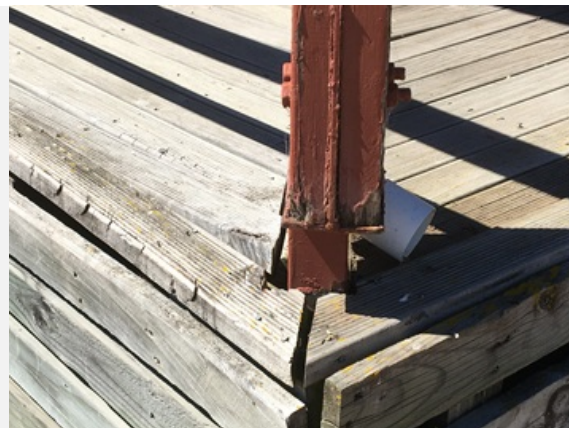
Verandah downpipes discharge onto the deck rather than into a stormwater drain (photo 15). The rainwater head has corroded to the point of failure (photo 16).

Photo 15. Verandah downpipe

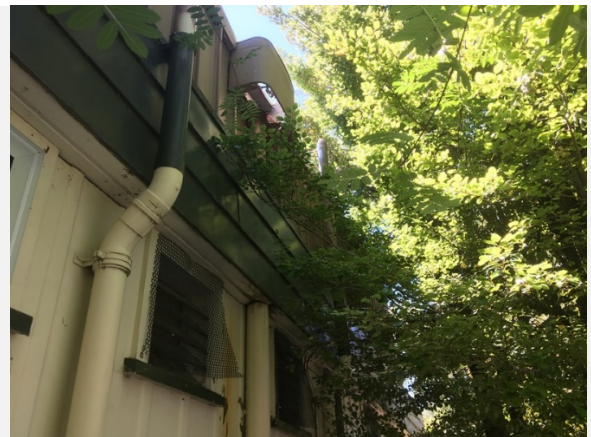
Photo 16. Rainwater head
